SUMMARY

98 Mystic Dr, Norwich, VT 05055

March 21, 2024

Dan Jones
InterNACHI certified
W.R.V. Home Inspection, PLC
603-762-7599
wrvhome@gmail.com

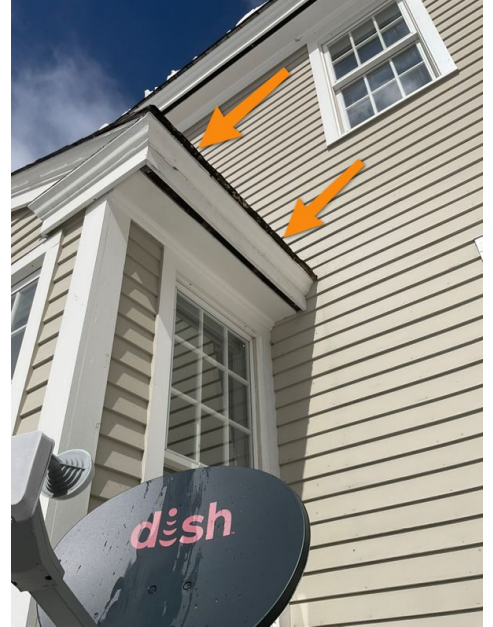
- No drip-edge flashing installed at cedar eaves and I noted moderate moisture intrusion and some decay to cedar edges particularly at the back eave.

From what I could see, this is becoming the weak-point in the roof covering. The cedar can wick moisture up its length/under shingles.

Uncapped cedar absorbing a lot of moisture

Expect that eave repairs will likely be needed before the main roof has come to the end of its life.

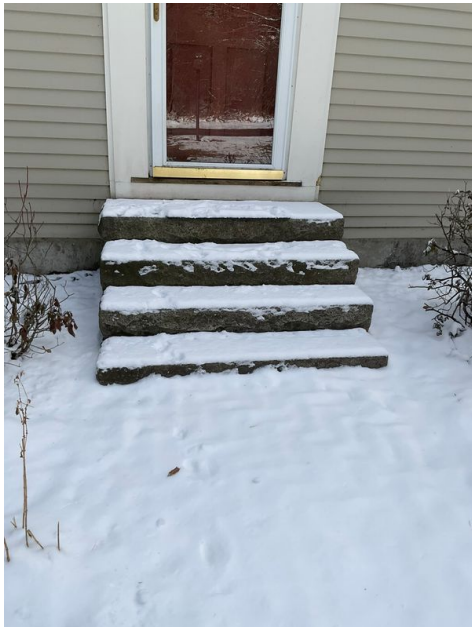
- At the front entry door splash off the stone steps has lead to casing and jamb decay.

Splash at front steps

Repairs will be needed, and I recommend installing flashing between the stone and home to protect wooden siding (damp behind stone as well).

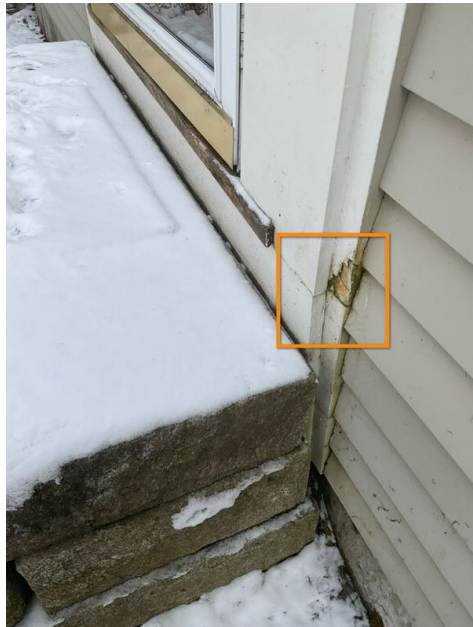
Decay at front entry

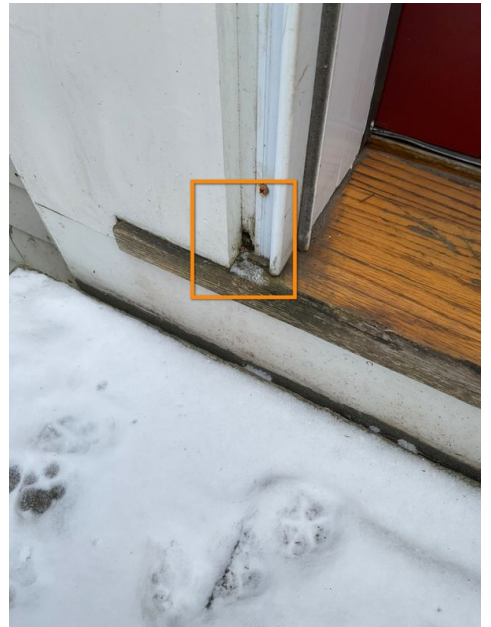
Ditto at front entry jamb

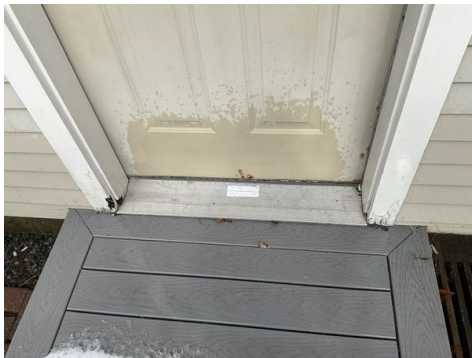
Garage rear

- At the back door the the garage splash has rotted the casing and jamb. A diverter was added at the eave above, but at the time of the inspection this door was still receiving a lot of splash. Door frame repairs or (more likely) replacement will be needed.

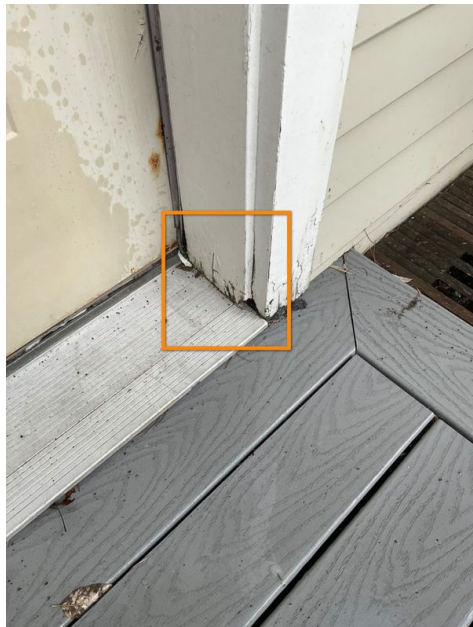
Rotting jamb

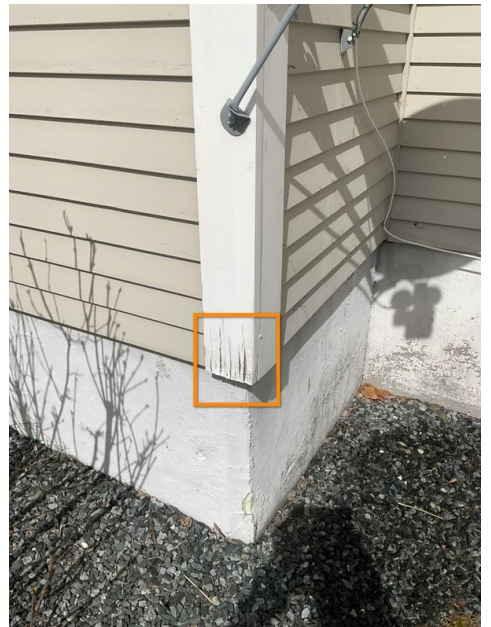
Back corner

- Similar decay noted to corner trim at the back of the home and lattice wrap/trim around the back porch as well as bottom edges of garage door casings

Siding and trim repairs needed. Adding gutters and correcting grading around the home will likely be beneficial as well.

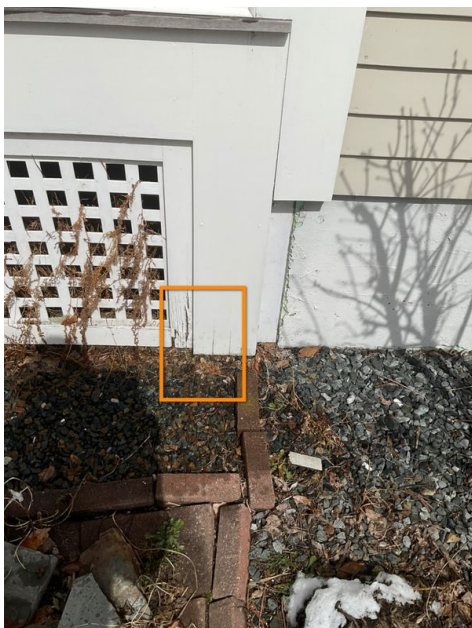
Lattice and porch trim

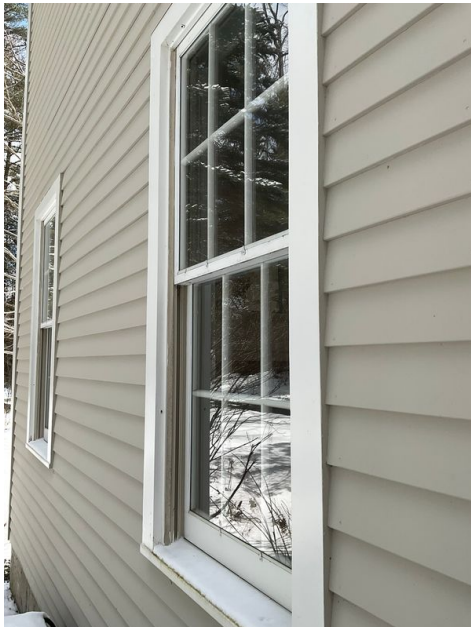
Decay to window sills and bottom edges of window jambs is common for this age and style of Brosco window.

Brosco Window units

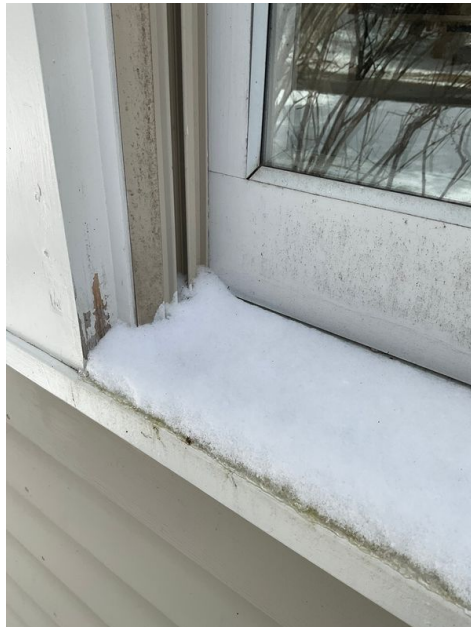
- Sills, jambs and sashes are due for painting/re-sealing

Keep sills and jambs sealed

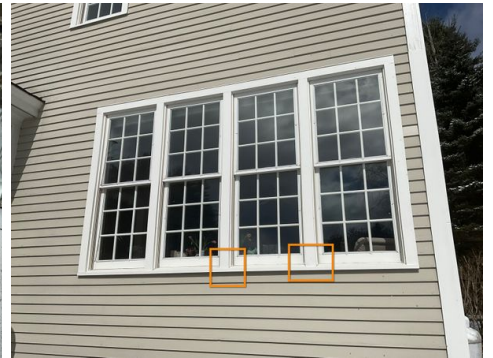
- Decayed window casings noted intermittently around the home (most notable at the back of the living room)

Casing decay

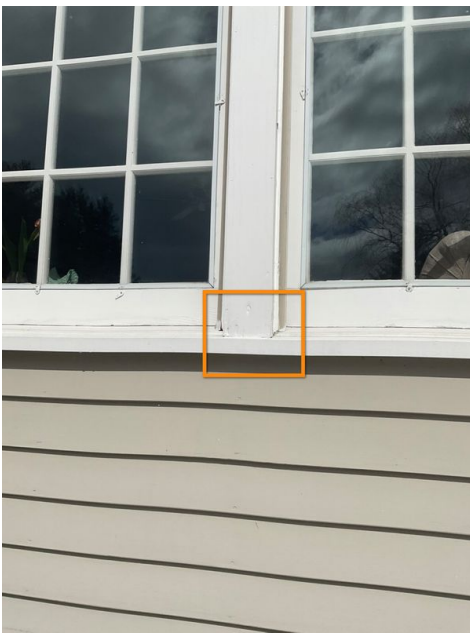
Soft behind paint

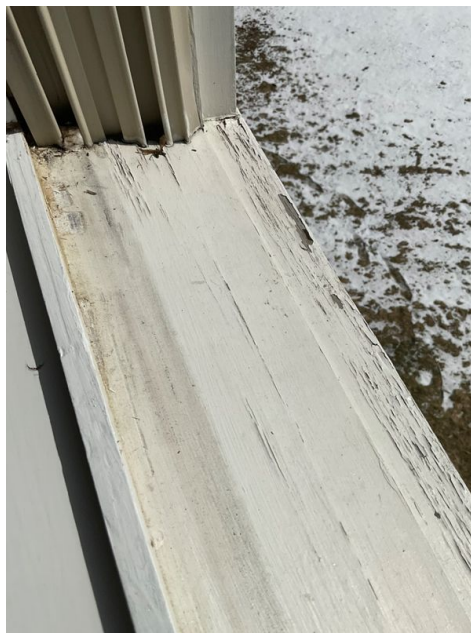
Paint/protect sills

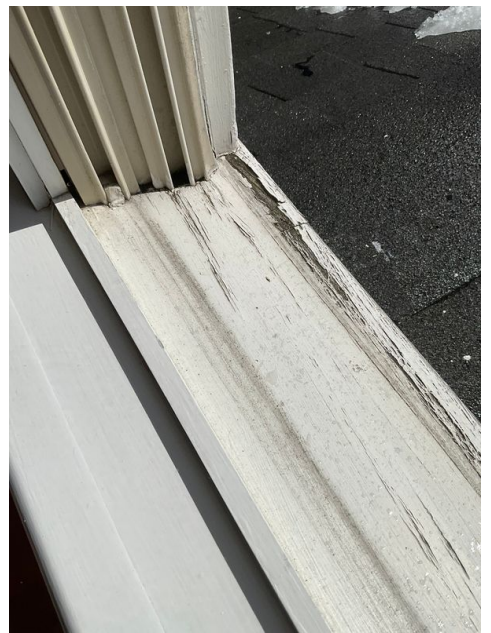
Ditto

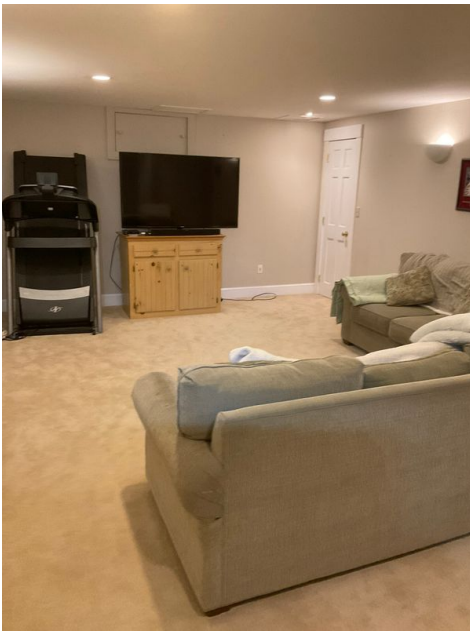
Basement living areas lack direct egress.

No egress

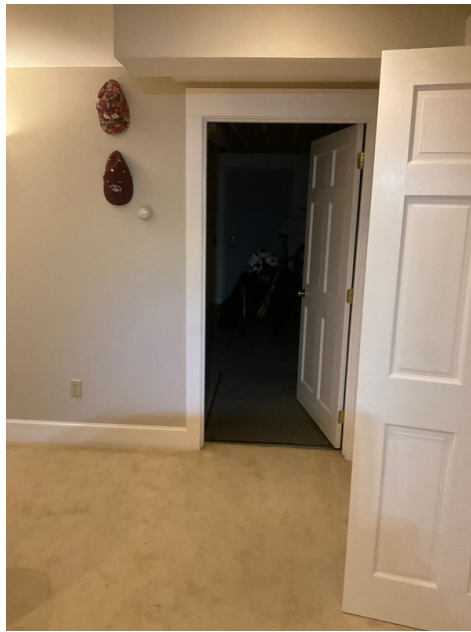
- No egress from living room, and basement door leads to garage (not directly to outdoors as required). Additionally, for a stairwell to qualify as egress it must be lit and have a handrail.

Through utility room into garage

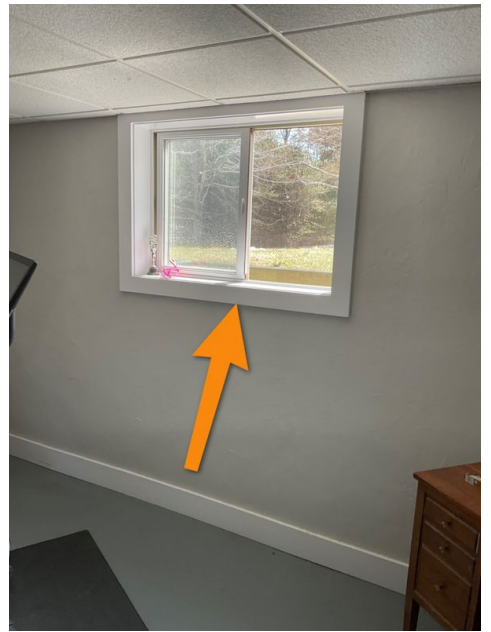
- Windows in boiler room are too high above ground for egress

Too high for egress and not in living room

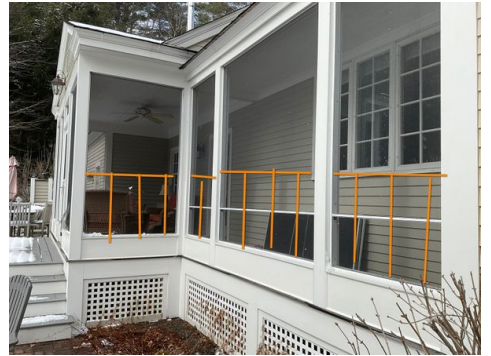
Because of the height of the screen porch (30 inches or greater above the ground) railings should be installed.

The railings should be set 36 inches high (minimum), and no opening below the top rail should exceed 4 inches.

Proper railings should be installed by a qualified contractor.

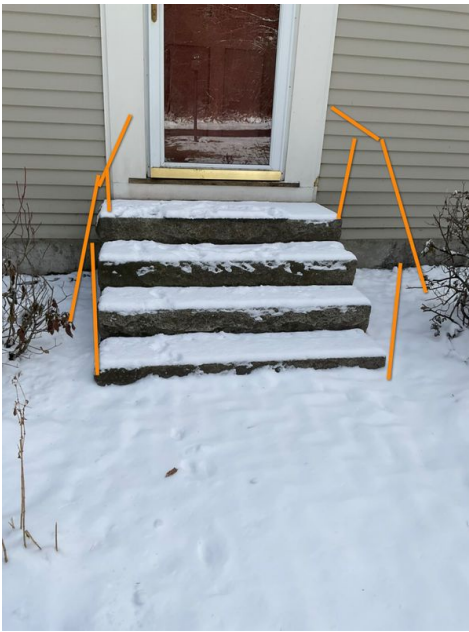
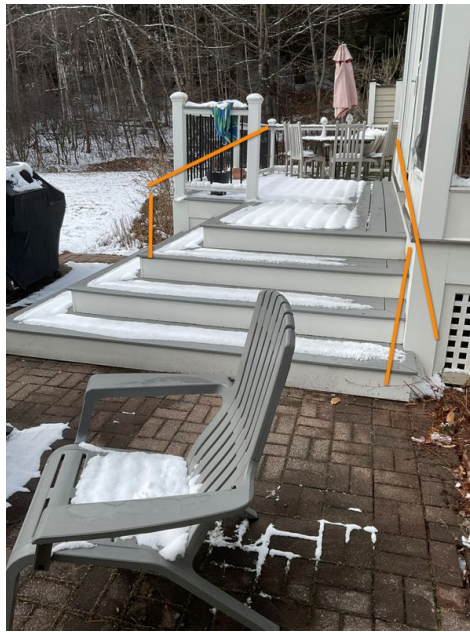
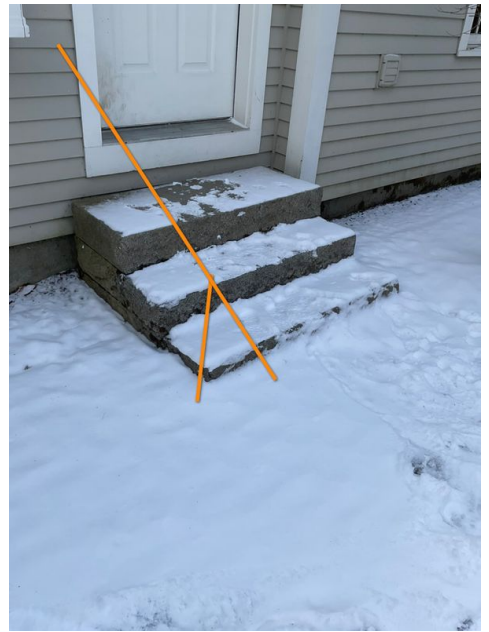
- No handrails installed at front entry steps

- No handrail installed at el entry steps

- no handrails installed at deck steps

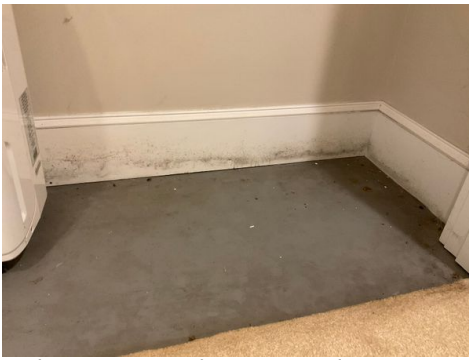
Staining noted on baseboard trim in basement closet, storage area and in the area of the water softener. This is light staining consistent with mold/fungal growth from elevated moisture.

Light staining at basement closet

Assessment and cleaning by a mold remediation company would not be a bad idea for this space.

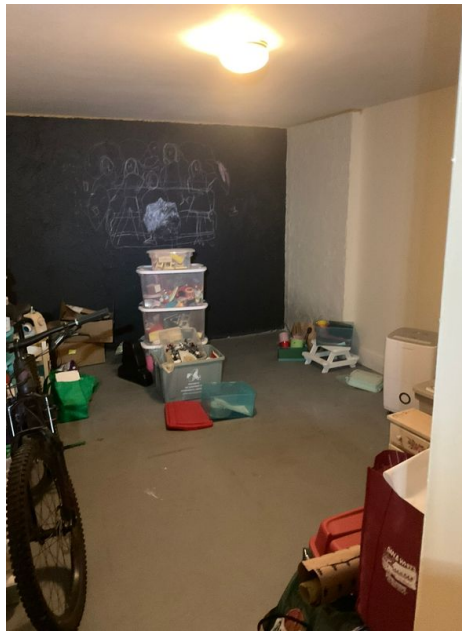
Storage room

- One self-draining dehumidifier installed in closet, staining remains in this area and should be cleaned
- not self-draining dehumidifier in storage area; this is only as effective as you are at emptying the collected water

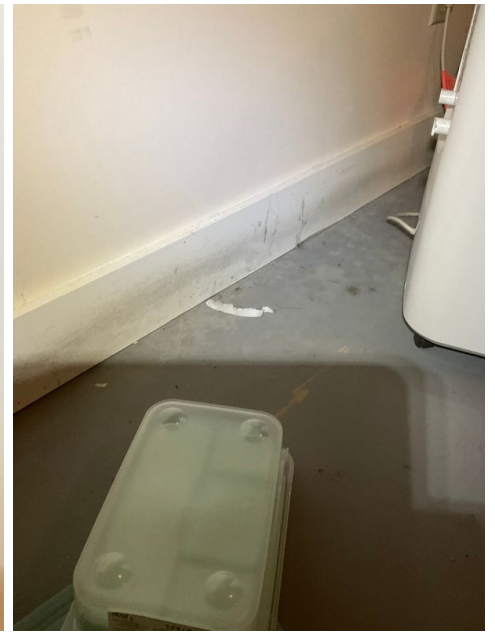
Light staining on baseboard

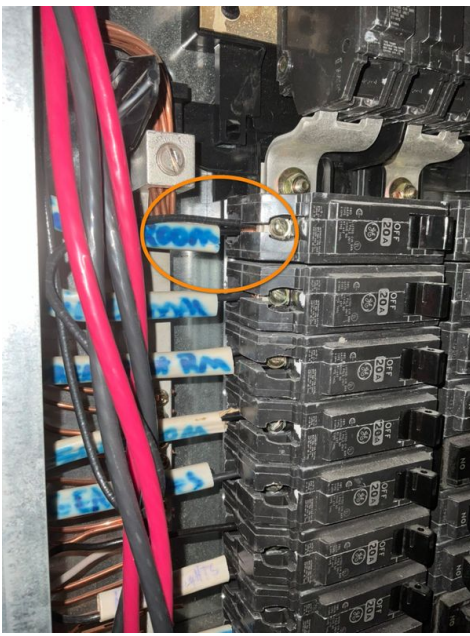
There is a breaker (#1) in the main panel that has been double tapped.

This is a common occurrence, but it is considered incorrect/unsafe wiring practice.

I recommend correction by a qualified electrical contractor.

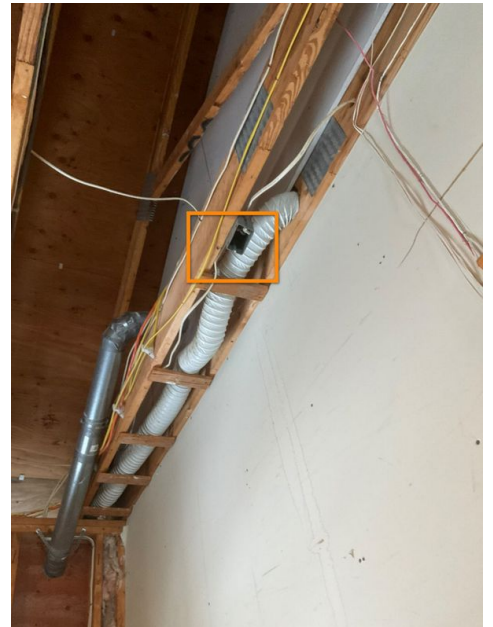
In the home there is an uncovered junction box.

- garage ceiling 1x

ALL receptacles need to have an appropriate cover installed.

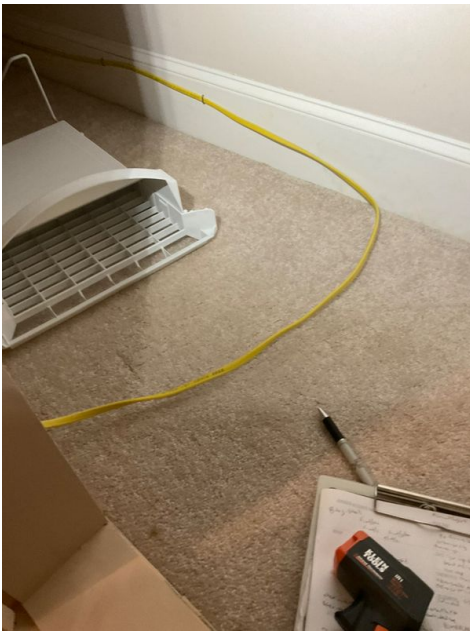
- Unsecured and unprotected wire in master bedroom knee-wall storage area.

This can allow wire to be damaged or snagged.

This should be secured and better protected.

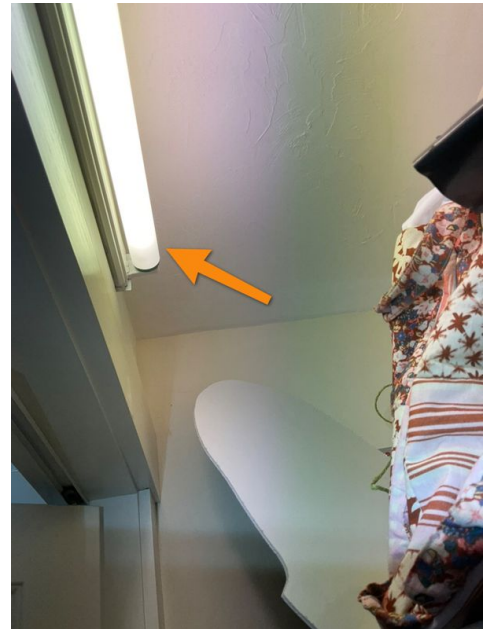
Uncovered fixtures were found:

- in bedroom closets

I recommend having a qualified electrical contractor install a covered fixture in this location.

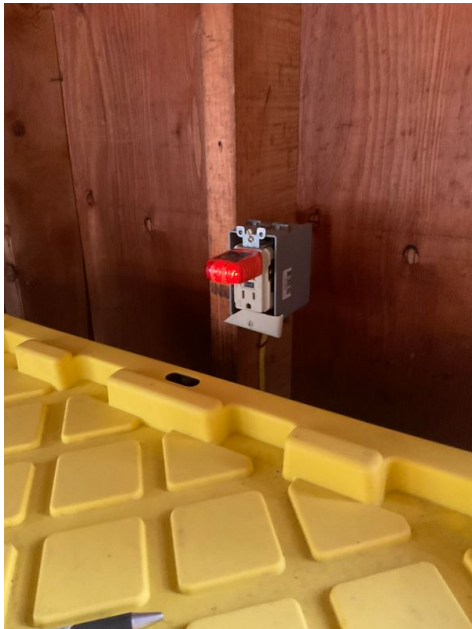
Garage

- garage (one existing GFCI no longer functions, and this needs a new cover plate as well)
- basement utility area incomplete
- Kitchen (one inoperable GFCI, one unprotected outlet by fridge)

The outlets in the following areas should be upgraded to GFCI protected units by a qualified electrical contractor.

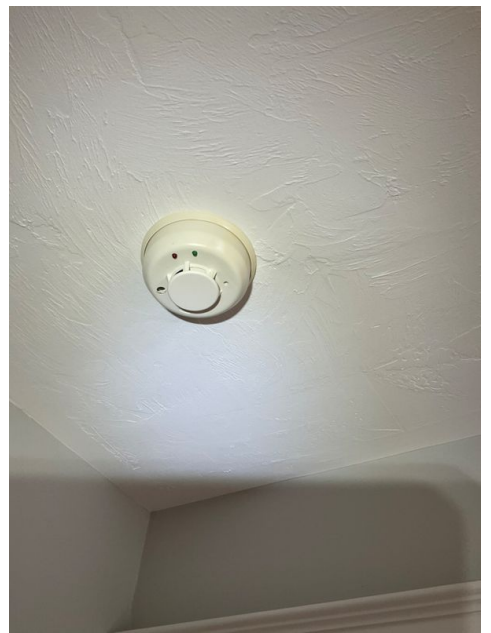
- Heat and one smoke detector tied to central system.

If not current/up to date, a local heat detector should be installed in the garage

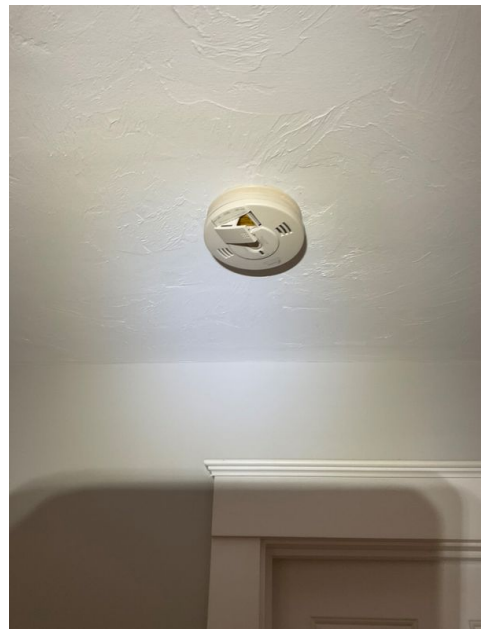
- Basement expired and lacks CO
- First floor hallway expired and lacks CO
- Second floor hallway expired
- bedrooms expired or expire in the next 6 months

Expired and disconnected in second hall

Detectors must be replaced at all locations.

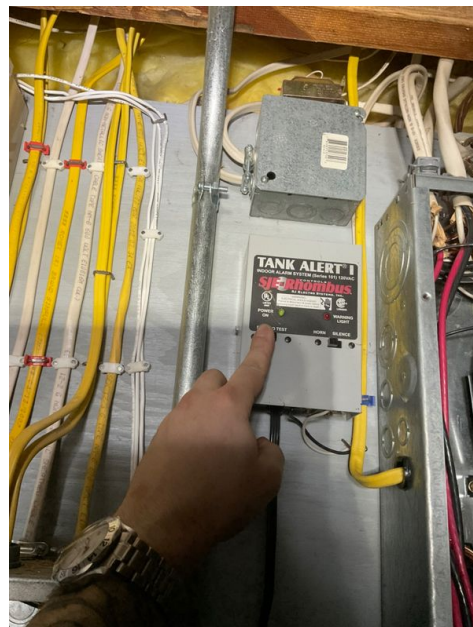
The septic pump alarm did not function during the inspection.
If this does not alert to pump failure you could end up with a real sewage issue.

No alarm!

the pump control/alarm should be replaced by a qualified contractor

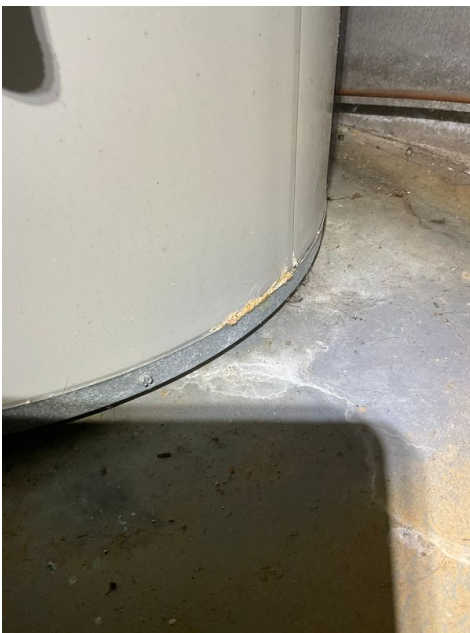
- The Bradford White (boiler fed) tank is starting to show its age with corrosion forming at the base and at the boiler inlet.

This unit was manufactured in 2007, and may be nearing the end of its life.

BW tank with base corrosion

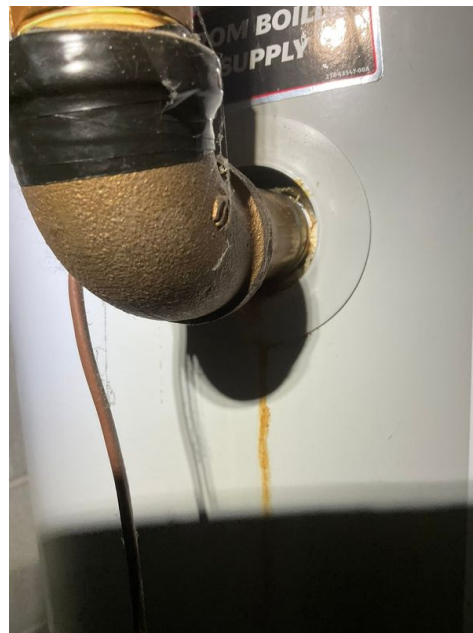
And weeping/corrosion at boiler inlet

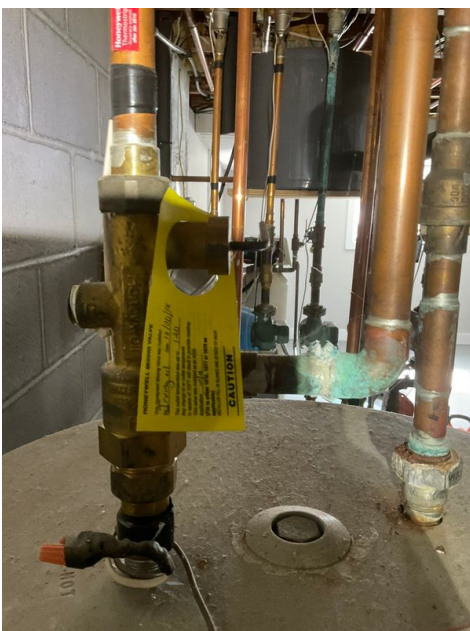
Mixing valve

- Domestic hot water does not have a mixing valve installed, but water temperature exceeded 140 degrees at fixtures.

the mixing valve should be adjusted or replaced by a qualified contractor

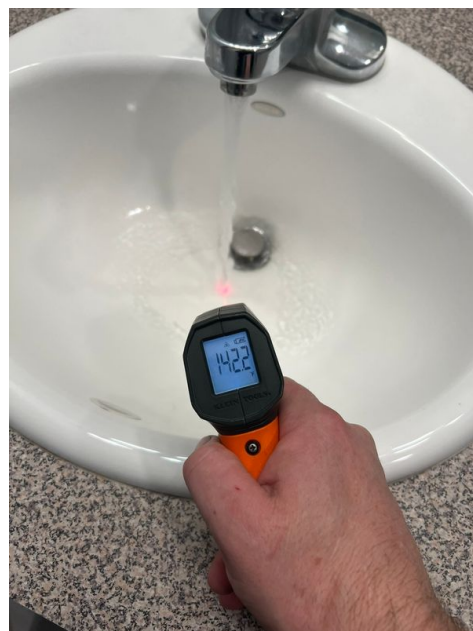
This is adequate to cause scalds/burns. Temperature should not exceed 125.

TOO HOT

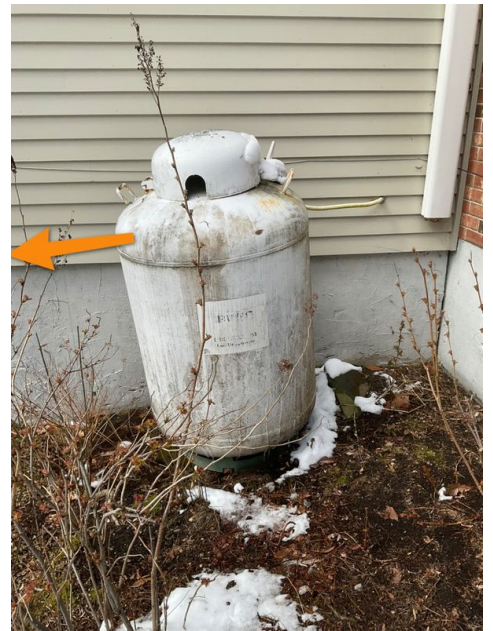
The blocks supporting the propane tank have settled and tipped. The tank and/or blocks should be re-set/shimmed to provide a stable base.

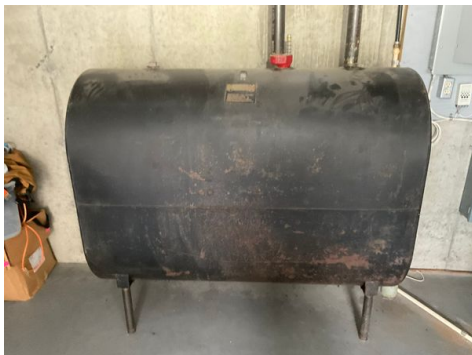
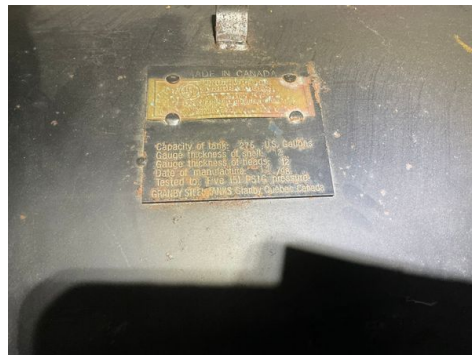
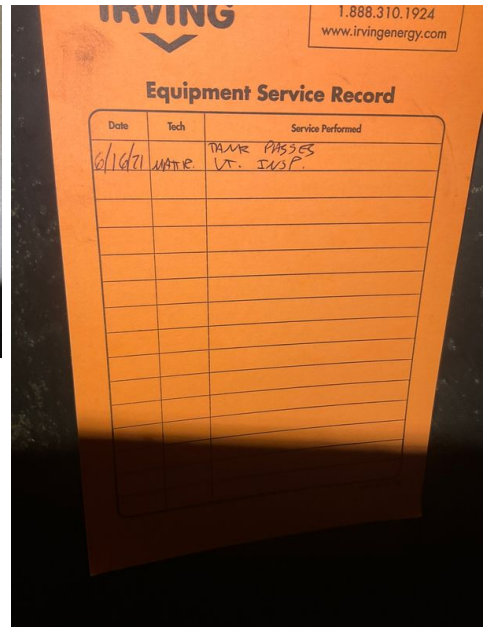
- Tank inspected in 2021, coming due for next inspection this summer.
Tank manufactured in 1998

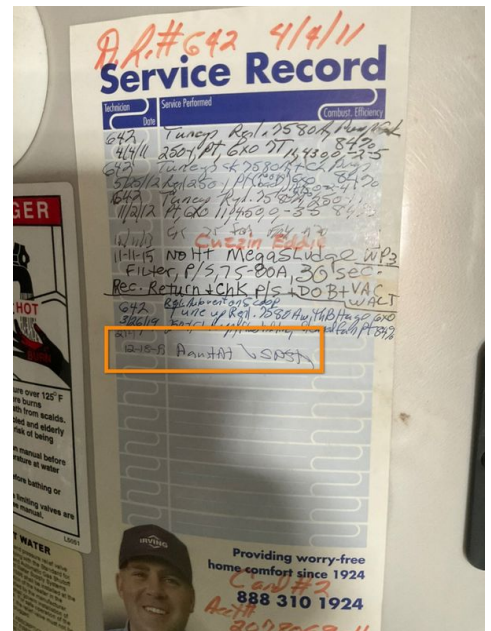
I was unable to locate a log of maintenance beyond 2019.

I recommend having this unit serviced by a qualified technician prior to use.

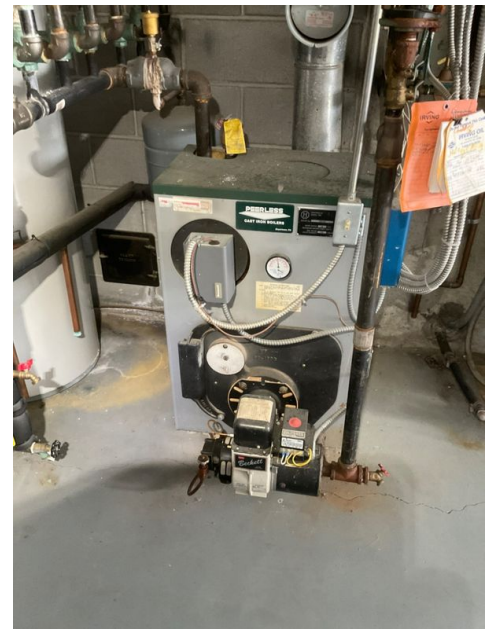
The boiler was manufactured in 1998

- This unit is showing it's age and records show dwindling efficiency (now barely above 80%)

It would be reasonable to plan for boiler replacement in the near future.

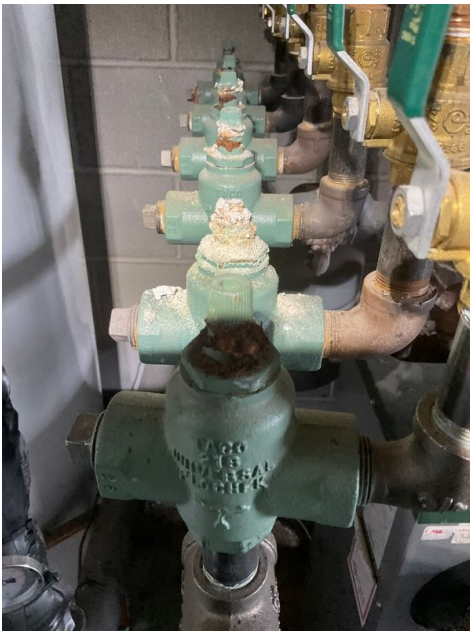
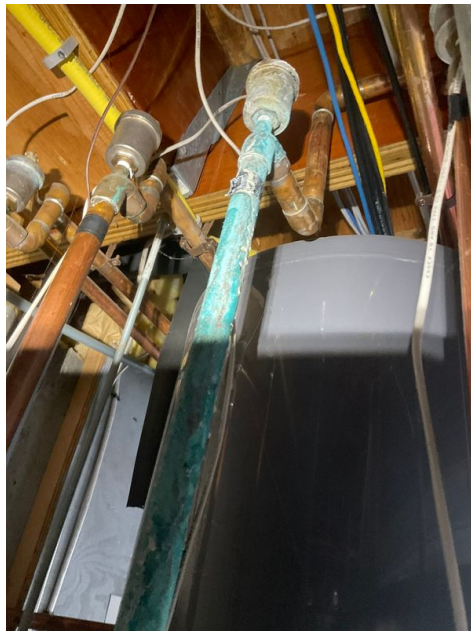
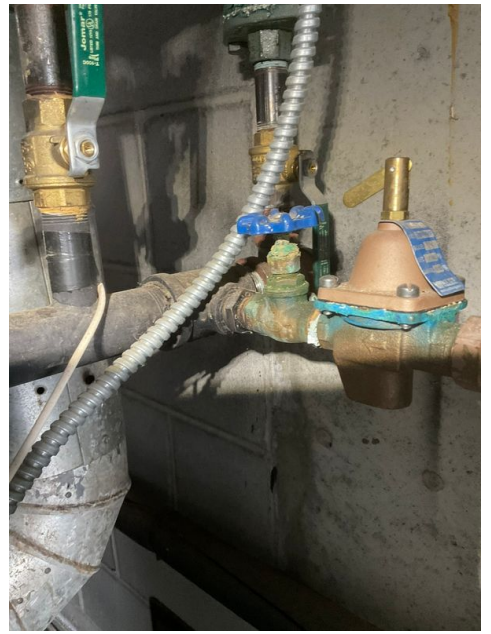
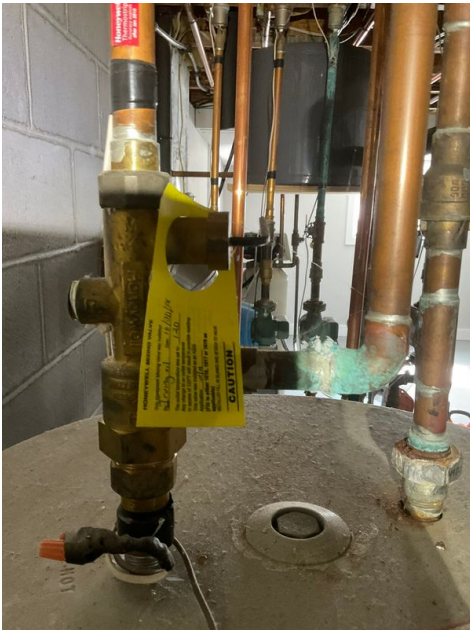
- Weeping and mineral buildup noted at valves and fittings throughout the system, including at mixing valve on transfer tank

The time for repairing/replacing valves and main heating distribution components is near

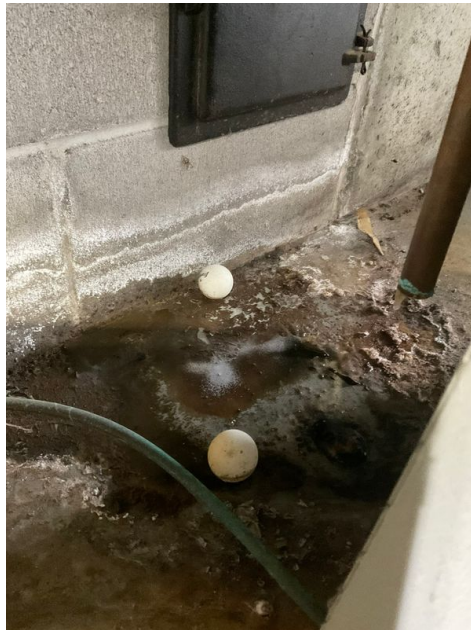
- Leaking TPR valve in need of replacement

TPR leak

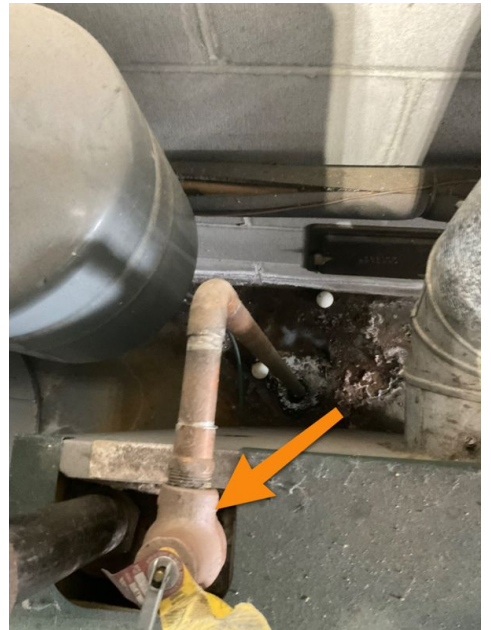
TPR leak

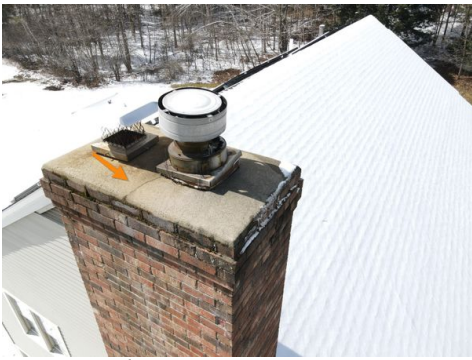
- Wash-cap at the top of the chimney would benefit from re-sealing
- minor moisture absorption/retention noted around crown (moss/algae growth).

Cap re-sealing upcoming

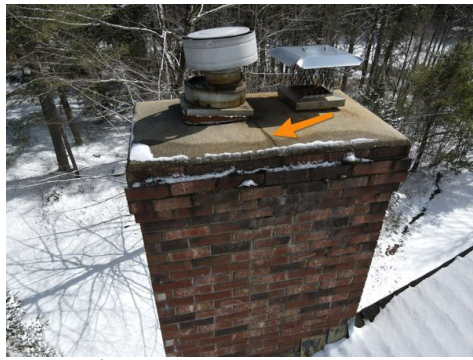
Cap sealing upcoming

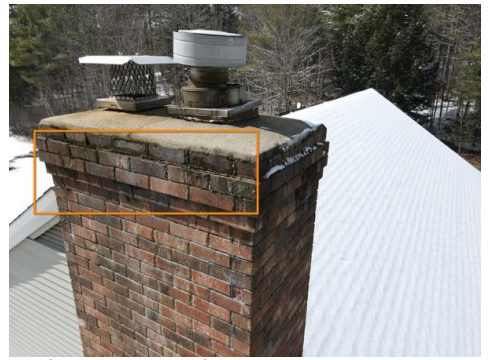
Early moisture absorption at mortar joints

Cleaning and re-sealing mortar joints will help prevent deterioration

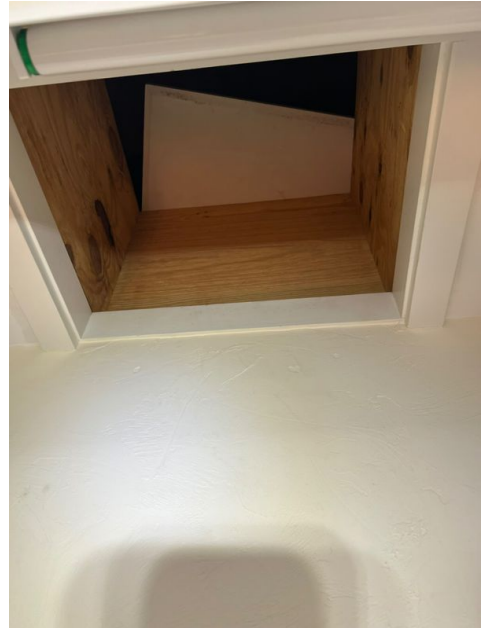
Bare hatch is the weak-point in attic insulation

I recommend installing insulation on the backside of the attic access door to minimize heat-loss.

Installing weatherstripping/seals around the hatch would also be a good idea.

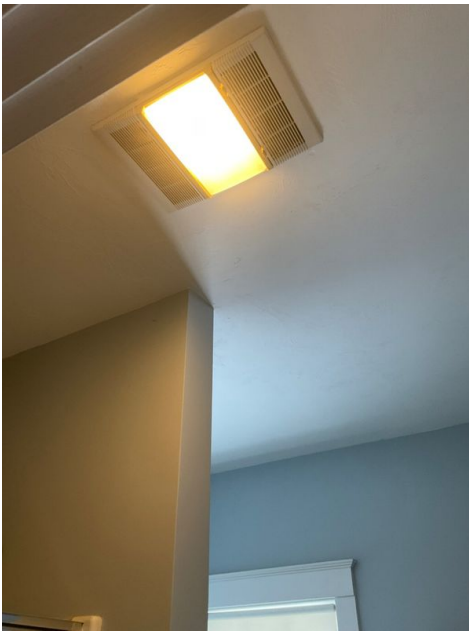
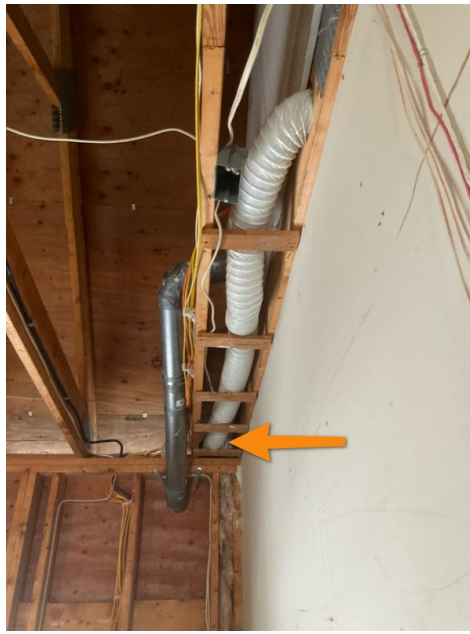
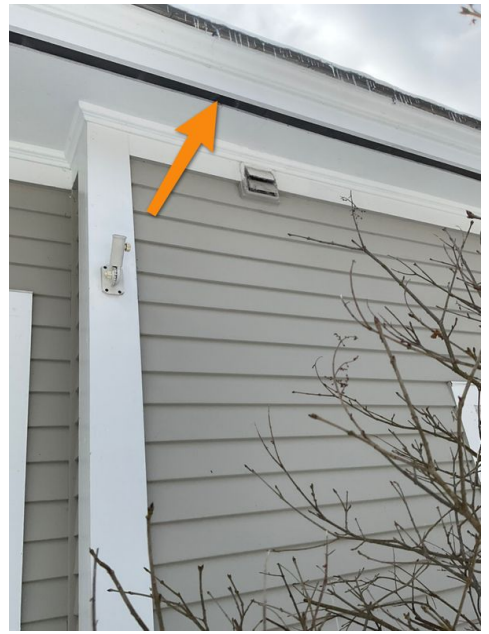
- The first floor bathroom fan is very loud, pulls minimal air and vents into the soffit (roof trim by el entry door).

I recommend replacing this fan and extending the vent to terminate outdoors

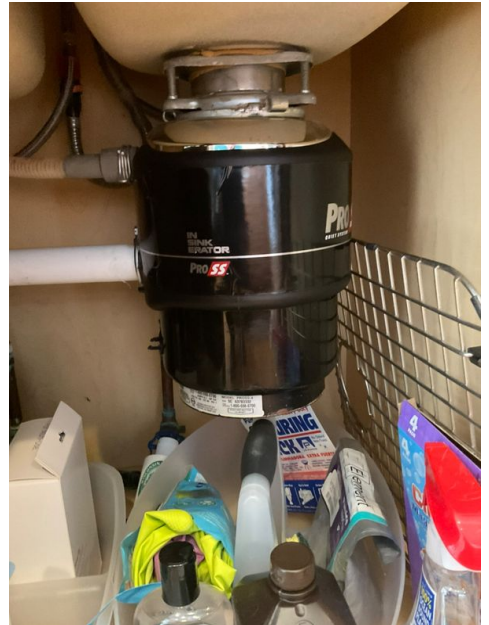
Garbage disposals are not generally recommended for use in homes with a septic system.

I recommend removing this appliance

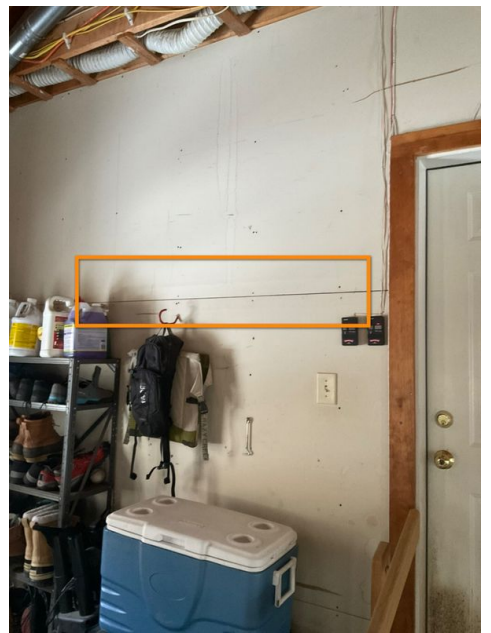
- to complete fire separation, drywall joints and fasteners should be finished with joint-compound

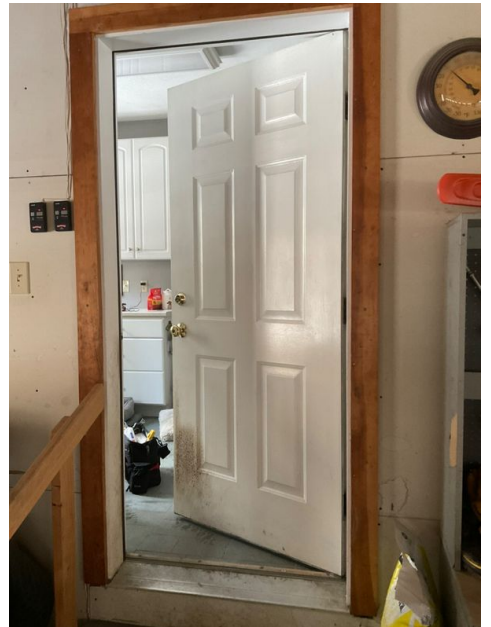
Doors separating garage and home does not meet safety standards.

Doors in firewalls must be at least 1 3/8-inch thick, metal/steel, or a 20-minute fire-rated door.

Glass in separation doors need to be fire-rated glass.

Additionally, the door should be installed on self-closing hinges.
