River Valley Home Inspections LLC

David M. DeSimone
ID: Board Certified and Licensed in NH and VT
244 Town Shed Road
Orford, NH 03777

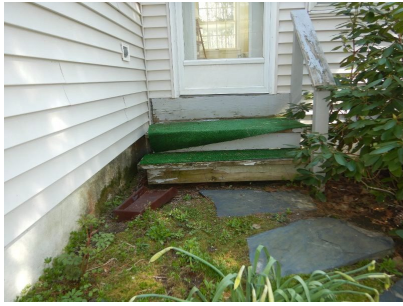
Rear Step.

~Step Reconstruction: As a result of material condition, settlement/leaning, tall steps and other defects, the steps will need to be reconstructed for safe passage into and out of the home.

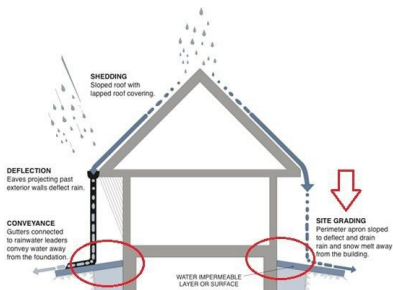
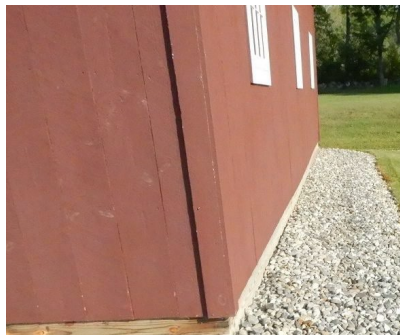
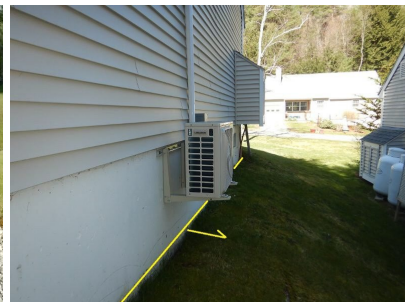
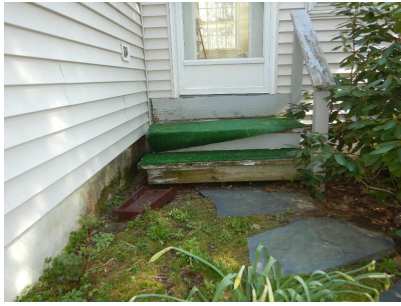
Side Of Home and Rear Area Near Step.

~Ongoing General Grading Needs: The grade along the perimeter of the home is an important factor in keeping moisture away from homes and allowing water to flow away from the home's siding, sills and foundation; A plan should be implemented to upgrade the current grading along the foundation including the walk out door area if present and any planting beds of the home; Grading first with vapor barrier with stone on top should be added to allow water to flow away from the foundation and limit dirt and water splashing onto the siding of the home; The top of the stone border should be at least 6 inches below the edge of the siding when establishing the grade of 5/8th inch pitch per foot fall and/or drained to move water away from the foundation.

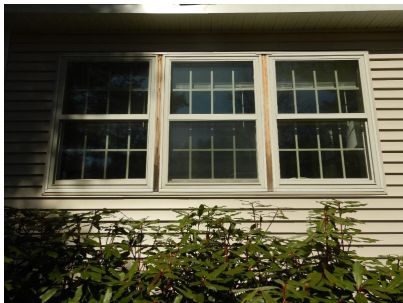
~Missing Trim Flashing: The exposed wood areas on the rear window will need to be properly finished to eliminate exposure to the elements that will impact the unprotected wood over time.

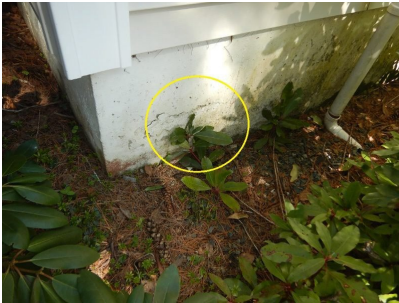
~Foundation Parging: Rear Spalling Areas: As a result age and weather, the concrete surface is beginning to spall in small areas of the foundation; A skim coat of mortar know as parging will need to be applied to the surface to secure further decline of the concrete surface; To protect the surface of the foundation, the surface should be cleaned and Parged with an appropriate cover application made for the existing surface material and the concrete surface sealed.

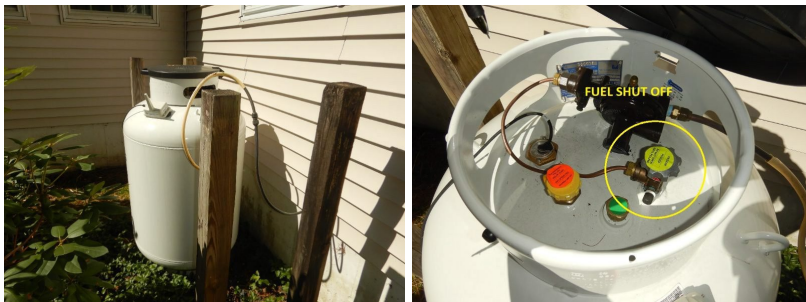
~Propane Tank, Piping and Regulator(s): The propane delivery company will need to be contacted to confirm the propane tank ownership and condition, meter condition if applicable, and the condition of the lines, shutoffs and regulators serving the home and adding that info to the buyer's file.

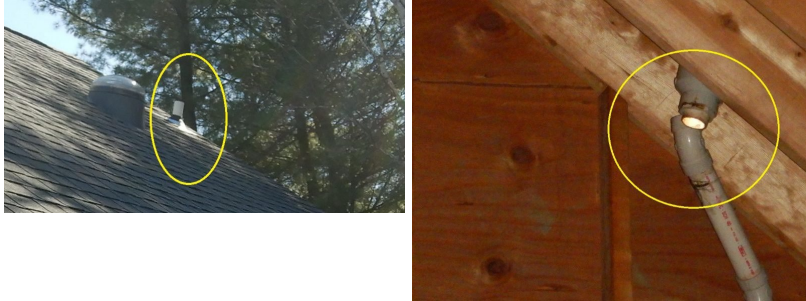
~Vent Stack Leaning/Damage/Disconnected: The sewer vent stack is leaning and appears to have been damage from snow/ice sliding from the roof; The vent pipe will need to be repaired to include the condition of the vent stack boot.

~Height: To avoid potential snow blockage of the vent pipes in winter, the vent should be extended to at least 12 to 18 inches to avoid snow blockage.

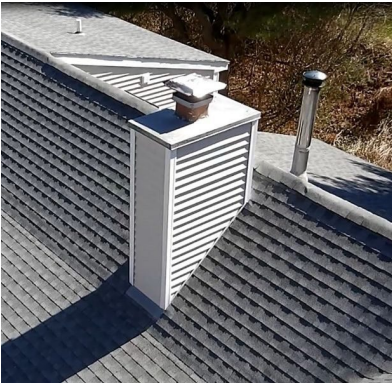
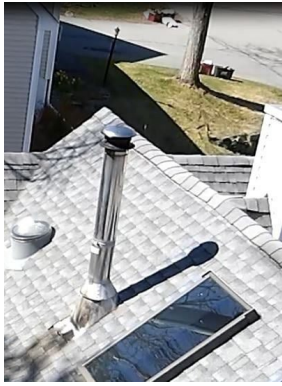
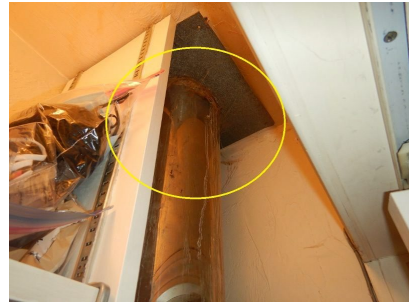
Corrosion Observed.

~Boilers, Furnaces and Gas Heating Appliances: Liner Status and Flue Condition Determination: A common overlooked maintenance item is the chimney inspection and cleaning of the furnace or boiler chimney; The chimney will need to be cleaned and fully inspected; In some cases the chimney will require the installation or repair of a liner to ensure the safety of the chimney.

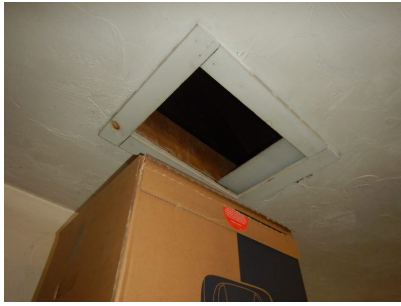
~Dwelling Separation Openings: The opening(s) into the garage attic space need to be properly fire separated to insure fire and flames are slowed in the event of a garage fire.

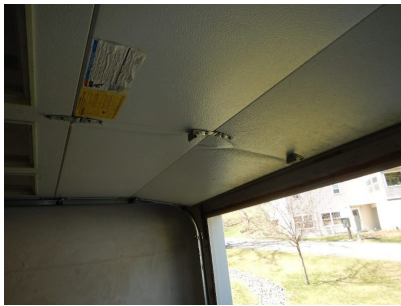
~Damaged Door Panels; While operating correctly, damaged interior door panels were observed with a slight push to the outside; To eliminate this condition completely, the damaged panels will need to be replaced.

~As a result of water and salt contact at the base of the garage doors rust conditions have formed; The door base needs to be sanded and sealed to eliminate the direct contact of the metal to the water and salt; In some cases, dependent on the extent of damage, the door panel cannot be repaired and will require replacement.

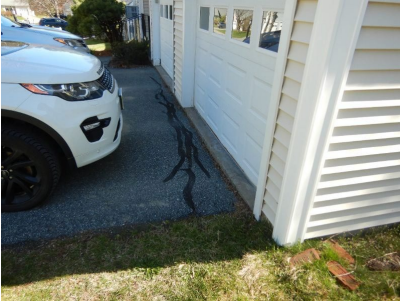
~Tall Edge: As a result of driveway settlement over time, the garage apron edge into the garage is tall and will need to be adjusted to eliminate the tall edge; Edges in this condition are tripping hazards: Methods to create an improved transition into the garage includes the leveling of the concrete, the addition of paving material or cutting/shaving the concrete edge or combination of all three or other methods; A professional driveway contractor will need to be consulted to determine and correct the observation.

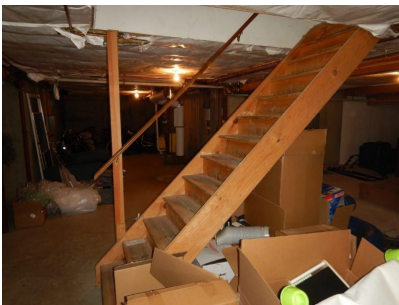
~Guards Added: Open Stair Sides: Appropriately spaced guards (balusters no more than 4 inches apart, cables, panels or a wall structure) needs to be installed on the open areas leading into the basement along the steps where the steps are more than 30 inches from the floor surface; Guard systems protect individuals from falling through or off the side of stairs in the event of a trip or fall down the stairs.

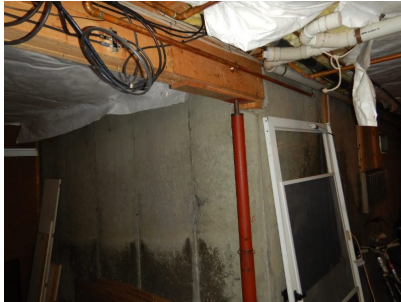
~Temporary Jack Post: A temporary jack post was observed in use in the basement; This is a common practice in many homes due to ease of installation; The jack, rated for a two year use in most cases, are used to support floor beams, stabilize floor sag and floor bouncing and should be replaced with permanent approved post; A plan should be created to replace/combine the temporary jack post with the thicker walled metal permanent jack post or wood post approved and properly secured for long term permanent installation.

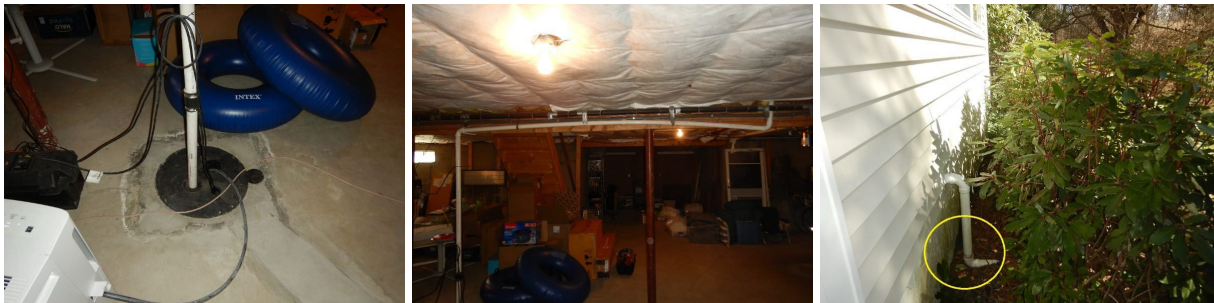
~Periodic Maintenance and Review: Sump pumps will need to be checked per manufactures or installers recommendation to include the pumps operation and to ensure pump floats and exit points remain clear of debris or items that may impact the pumps operations.

~Interior Run Transition and Connect Exterior Discharge Pipe: The exterior discharge line needs to be properly run to eliminate the bend in the line and the exterior discharge pipe elbow needs to be connected to allow water to flow correctly from the sump when activated.

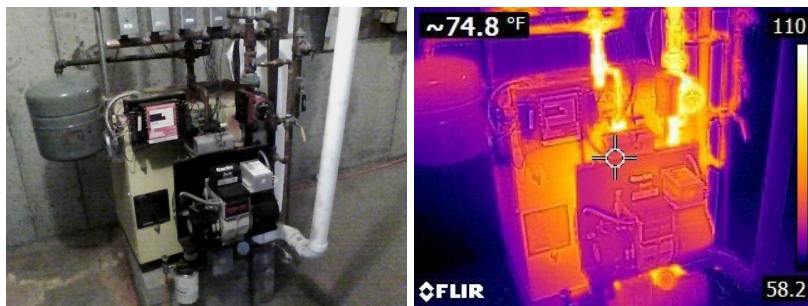
~Boiler Service and Service/Warranty Plans: 2024/25 Heating Season: Last Service Date Tag- 3/2024: The boiler fired and ran during the inspection process; To set the boilers baseline condition before the sale of the home, it is recommended a professional heating contractor be consulted to have the boiler serviced and cleaned and/or verification of the recent servicing documented if not completed this year in prep for the 2024/25 heating season; In addition, the boiler shroud, and all connecting pipes should be cleaned of corrosion and scale and the interior vacuumed and the unit wiped down to eliminate dirt and debris on the boiler surfaces; Oil fired boilers should be serviced every year to ensure the mechanical workings of the boiler are in satisfactory condition; All service records should be maintained for the buyers file.

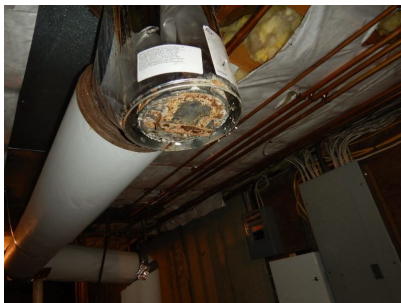
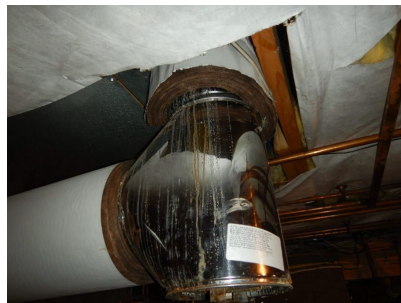
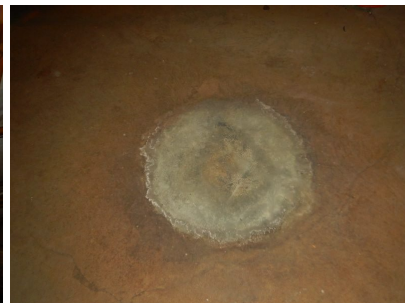
~Cleaning and Liner Status and Condition Determination: A common overlooked maintenance item is the chimney inspection and cleaning of the furnace or boiler chimney; The chimney should be fully cleaned and brushed, and follow-up cleanings scheduled per the maintenance company field recommendations; In some cases the chimney will require the installation or repair of a liner to ensure the safety of the chimney.

~Please see Section 3: Exterior Home Chimney notes.

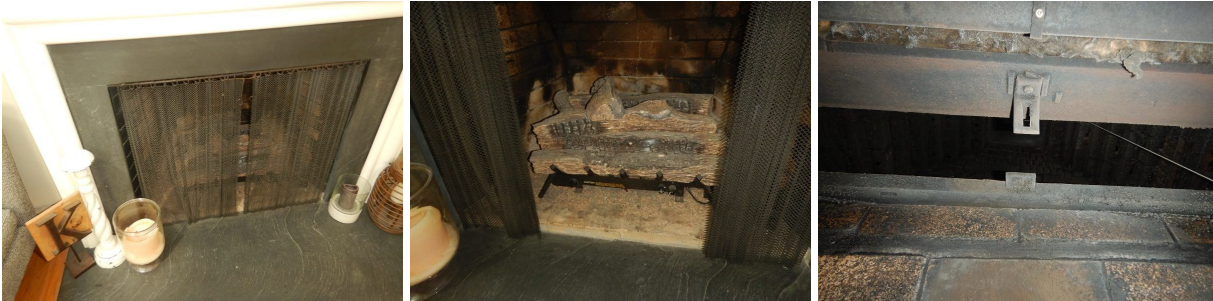
~Log Set Insert: Cleaning: Service: Pilot Light Off: The insert is off and will need to be leak tested and started; Like any combustible fuel home heating appliance and in preparation for the upcoming heating season, the unit will need to be serviced to include all CO safety shut off safety devices and damper blocking to ensure the unit is safe to use.

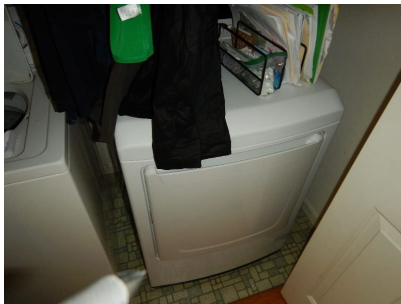
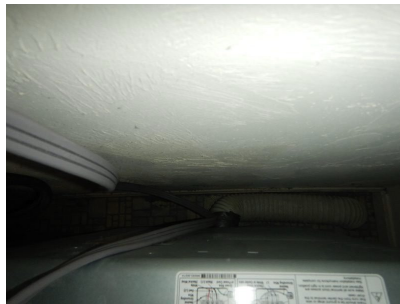
~Plastic Dryer Vent Pipe: An approved metal vent pipe needs to be installed.

~Important Fire Protection Maintenance: Yearly: Washer and Dryer Behind and Under Unit Clean-up: As an important maintenance task for fire prevention, the areas behind the washer and dryer cleaned and vacuumed of all lint, dust and objects that find their way behind the units over time; The dryer vent and all connecting venting hoses should be cleaned and if plastic vent pipes discovered replaced with metal and the termination point outside the home confirmed; The clothing washing machine plumbing and drain connections should be reviewed for proper installation and shutoff ability; The clothing washing machine is not tested as part of the inspection due to the possibility of leaving water in the unit; Verification of the units operability should be made with the seller if the unit is part of the sale.

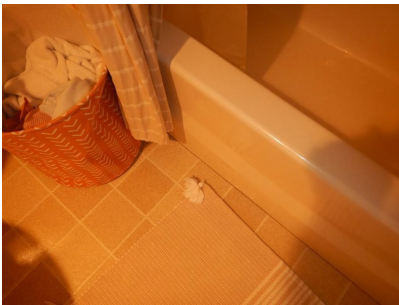
~The gap between the floor surface and tub base needs to be properly sealed.

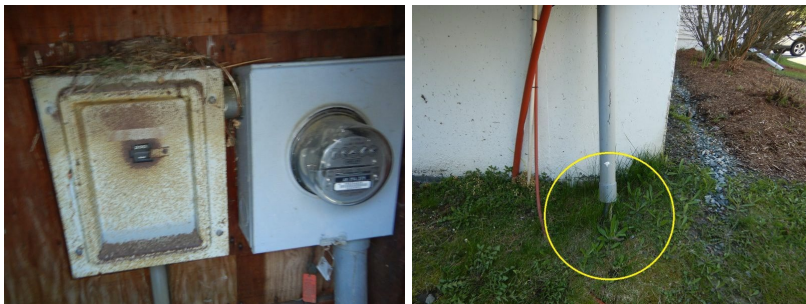
~Exposed High Voltage Conductor: As a result of conduit settlement, the conduit has separated exposing the high voltage service line into the home; The line needs to be properly protected.

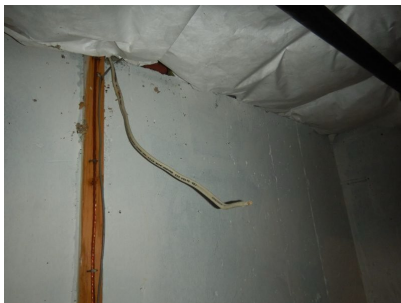
~Improperly Terminated Wire(s): All terminated wires require an approved junction box and cover installed over them to protect individuals and the wire from accidental contact.

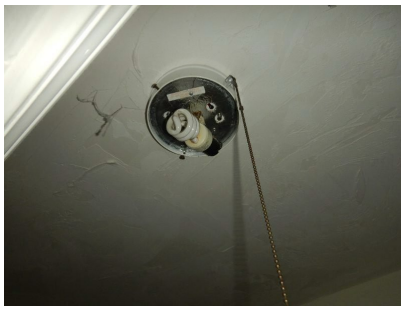
~Open Light Bulbs: All Closets: Light fixtures in closet locations did not have appropriate bulb covers installed; If not properly protected, open light bulbs pose a fire or breakage hazard in closet areas.
