River Valley Home Inspections LLC

David M. DeSimone
ID: Board Certified and Licensed in NH and VT
244 Town Shed Road
Orford, NH 03777

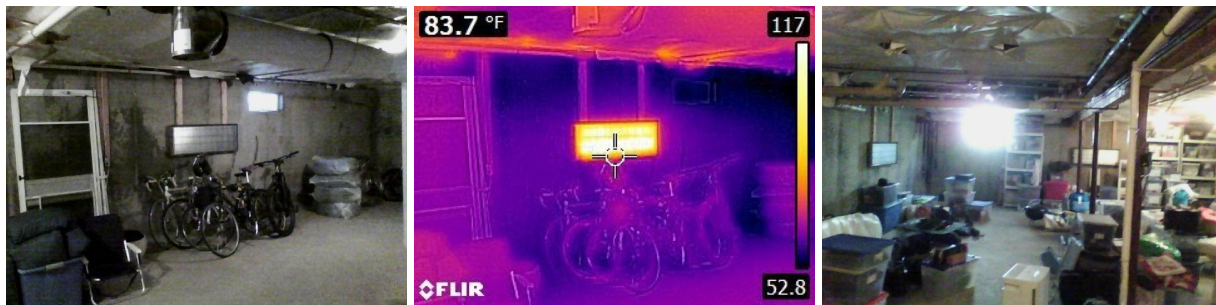
IR Electric Wall Unit Heat Tracing

~The homes secondary primary heat source is electric wall units; Each of the units was tested and operated as designed; Yearly maintenance on the units should be performed to include vacuuming the areas behind and below the baseboard covers; Additionally, more energy efficient electric Hydronic baseboard heating or electric wall panel units are available to help reduce operating cost.

~The homes secondary primary heat source is electric baseboard heat; Each of the units was tested and operated as designed; Yearly maintenance on the units should be performed to include vacuuming the areas behind and below the baseboard covers; Additionally, more energy efficient electric Hydronic baseboard heating or electric wall panel units are available to help reduce operating cost.

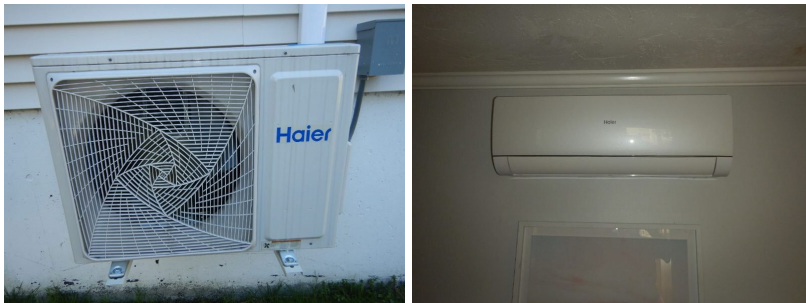
~Full System Service In Prep For Placing The Home On The Market: The home's secondary heating and primary cooling needs are limited to specific areas of the home and are completed by an installed heat pump system; Like any heating and cooling appliance, yearly maintenance on the unit is important to the continued operation and efficiency of the unit's operation; A heating and air conditioning service company should be consulted about the yearly inspection and maintenance of the units to ensure they are operating at peak heating and cooling efficiency for the new buyer.

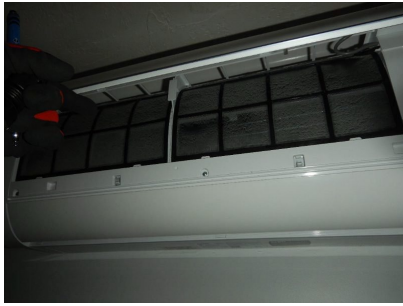
Clean Filters

~All Units: Filter and Fan Housing Cleaning: Electric power to the unit will need to be turned off before any work is completed in the filter compartment of the heater; Air filters should be washed or vacuumed per

manufacturers suggested periods to ensure proper air flow and air filtration in the home; The full space and all fan components should be cleaned and vacuumed to remove debris.

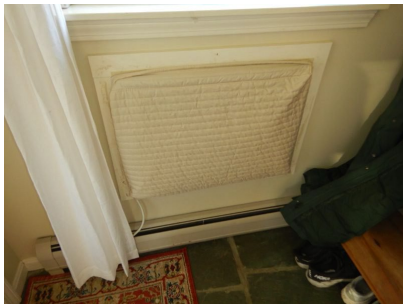
~Not Tested: Window air conditioning units are not tested as part of the inspection scope; Cleaning of all filters and verification of the unit's operation will need to be confirmed before the home is placed on the market.

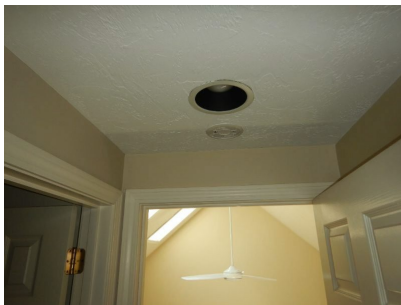
~NFPA Guidelines and Best Practice: A Good Safety Practice: *Choose smoke alarms that have the label of a recognized testing laboratory; *Install smoke alarms inside each bedroom, outside each sleeping area and on every level of the home, including the basement; *On levels without bedrooms, install alarms in the living room (or den or family room) or near the stairway to the upper level, or in both locations; *Smoke alarms installed in the basement should be installed on the ceiling at the bottom of the stairs leading to the next level; *Smoke alarms should be installed at least 10 feet (3 meters) from a cooking appliance to minimize false alarms when cooking; *Mount smoke alarms high on walls or ceilings (remember, smoke rises); *Wall-mounted alarms should be installed not more than 12 inches away from the ceiling (to the top of the alarm); *If you have ceilings that are pitched, install the alarm within 3 feet of the peak but not within the apex of the peak (four inches down from the peak).
